NASA Technical Memorandum 105355

Properties Data for Opening the Galileo's Partially Unfurled Main Antenna

Kazuhisa Miyoshi and Stephen V. Pepper
Lewis Research Center
Cleveland, Ohio

February 1992

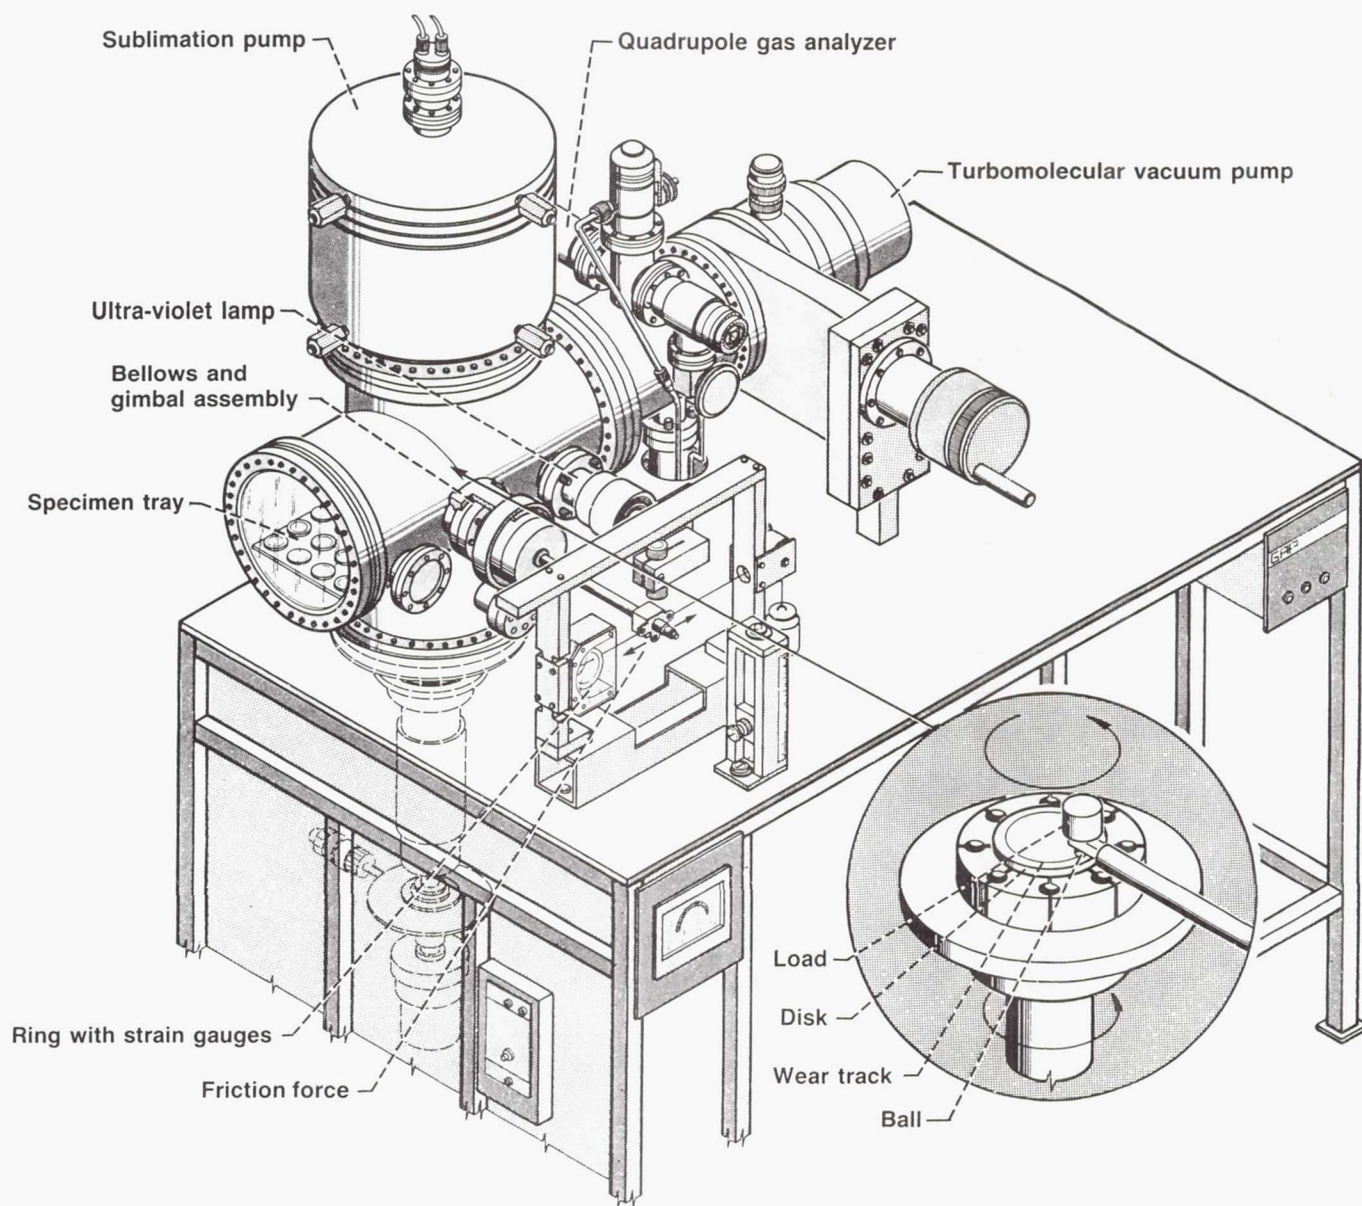
Figure 1.—Vacuum friction apparatus.

The tribometer (vacuum friction apparatus) is shown in figure 1 (ref. 2). The apparatus consists of a pin-on-disk assembly mounted in an ultrahigh vacuum chamber, a drive system, and a friction force measuring system (also shown in fig. 1). All components within the vacuum chamber are compatible with oxidizing, inert, or reducing gases.

The disk specimen is mounted on a shaft that is driven by a gear motor connected to a rotary feedthrough with a ferrofluidic seal. The drive assembly provides rotation at various speeds, which are regulated by a dc-motor speed controller. During disk rotation, the pin scribed a circular wear track on the flat surface of the disk. The bellows assembly permits rotation at various track diameters. The pin specimen is mounted in a holder attached to one end of a stainless-steel beam. The beam is welded into a bellows assembly which is gimbal mounted to the vacuum-chamber wall. The gimbal mounting permits deadweight loading of the pin against the disk surface. At right angles to the deadweight loading, the beam containing the pin can move in two directions in the horizontal plane. Movement of the pin (with the disk as it rotates) is restrained by a cable which is attached to a beryllium-copper ring. The ring contains four sets of strain gauges to measure the friction force between the pin and disk specimens. The friction force can be continuously recorded by a strip chart recorder or by a computerized data acquisition system during friction experiments.

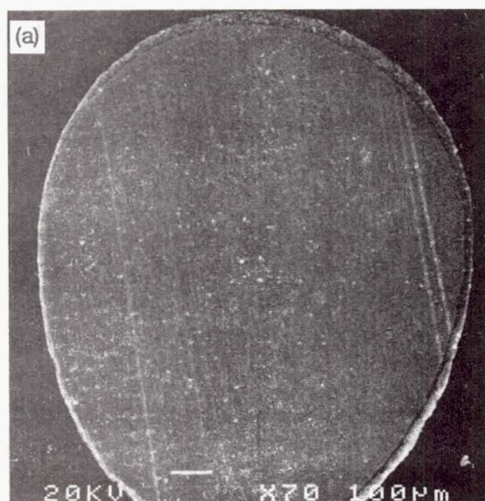
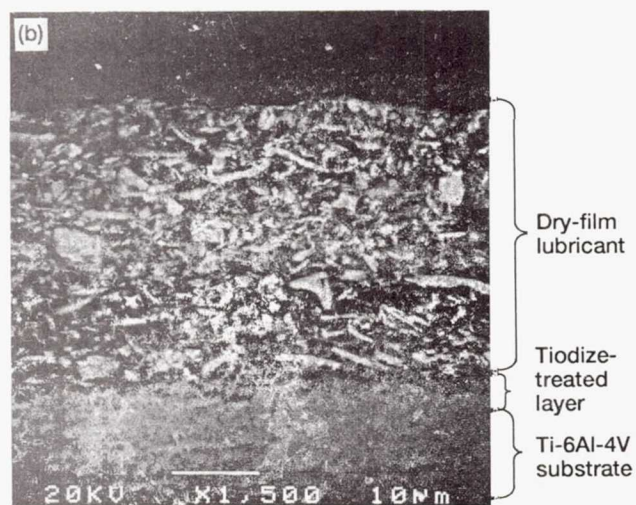
(a) Overview of pin.

(b) Details of dry-film lubricant, Tiodize treated layer, and Ti-6Al-4V substrate.

Figure 2.—Taper cross section of dry-film-lubricated Ti-6Al-4V pin at an angle of 45°.

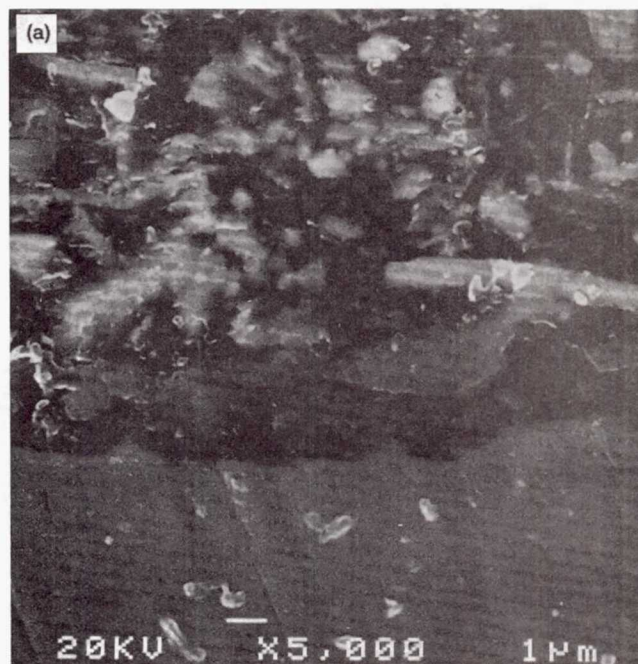
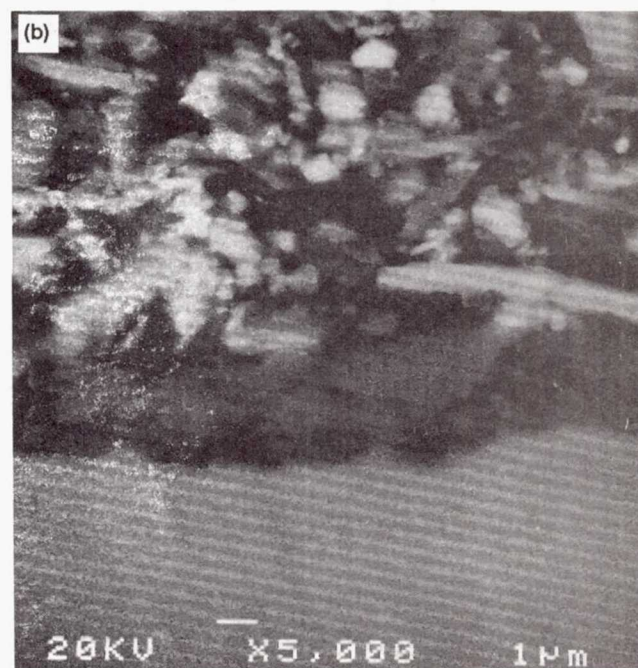
(a) Secondary electron image SEM.

(b) Backscatter electron image SEM.

Figure 3.—Structure of dry-film-lubricated Ti-6Al-4V pin.

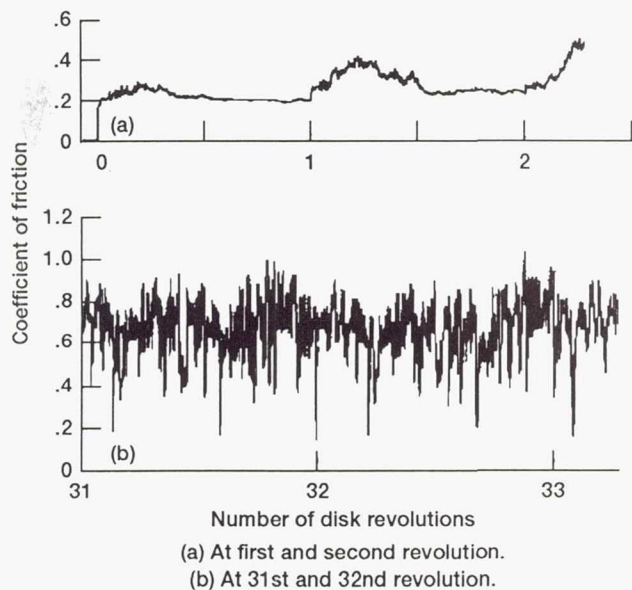
Figure 4.—Friction trace for unlubricated Ti-6Al-4V pin sliding against Inconel 718 disk at 2.5 N in vacuum.

Friction.—Friction traces (plots of the coefficient of friction versus the number of disk revolutions) for the unlubricated system measured at 2.5 N are presented in figure 4. The traces for the first three or four disk revolutions are characterized by randomly fluctuating behavior, with only occasional evidence of stick-slip behavior (e.g., fig. 4(a)). The presence of oxides and contaminants on the surfaces of Ti-6Al-4V pin and Inconel 718 disk contributed to this relatively low coefficient of friction. Stick-slip behavior becomes dominant after five disk revolutions. The higher the number of disk revolutions, the greater the stick-slip behavior. The traces for 10 disk revolutions and above are primarily characterized by a continuous, marked stick-slip behavior, as shown by the representative section in figure 4(b). This type of friction is anticipated where strong metallic interactions occur at the interface due to the removal of the oxides and contaminants from the alloy surfaces by sliding action.

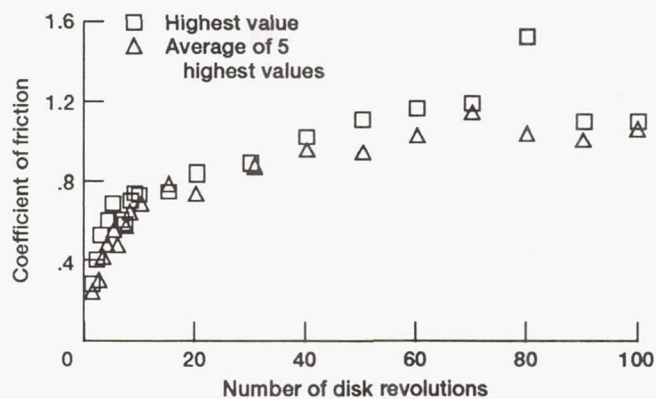
Figure 5.—Coefficients of friction for Ti-6Al-4V pin sliding against Inconel 718 disk as function of number of disk revolutions at 2.5 N in vacuum.

The coefficients of friction, calculated from the highest value and from the average value of the five highest values of friction within a given revolution, are presented in figure 5. Both coefficients of friction increased with increasing number of disk revolutions and reached equilibrium values (0.9 to 1.2) after 40 to 50 disk revolutions. The abnormally high coefficient of friction (1.45) at 80 disk revolutions is probably due to wear debris clogging the sliding interface.

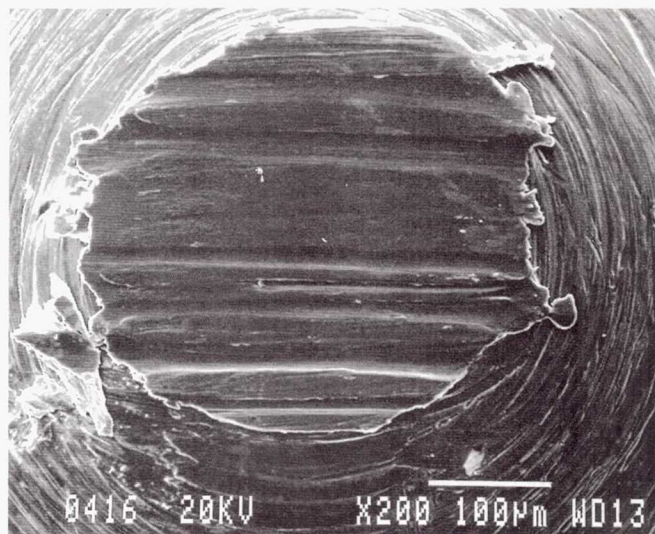
Figure 6.—Wear scar produced on unlubricated Ti-6Al-4V pin after sliding against Inconel 718 disk at 2.5 N in vacuum.

Wear damage.—Scanning electron microscope (SEM) photographs and energy dispersion x-ray analysis (EDX) spectra of the damage produced on the pin and on the disk after 100 disk revolutions at a load of 2.5 N are presented in figures 6 to 9. Figure 6 shows that substantial plastic deformation occurred on the pin. Large wear debris particles formed by plastic deformation and ductile fracture of the Ti-6Al-4V pin are present around the wear scar. Also, plastically deformed grooves and clogged wear debris are present on the wear scar of the pin. Closer SEM examination and EDX analysis of the wear debris showed it to be composed primarily of elements from the Ti-6Al-4V pin (fig. 7) and of small amounts of chromium, iron, and nickel from the Inconel 718 disk.

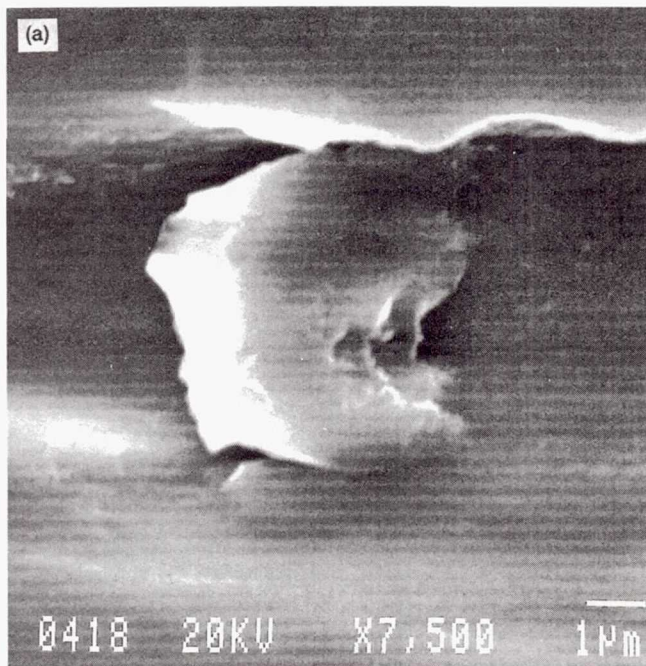
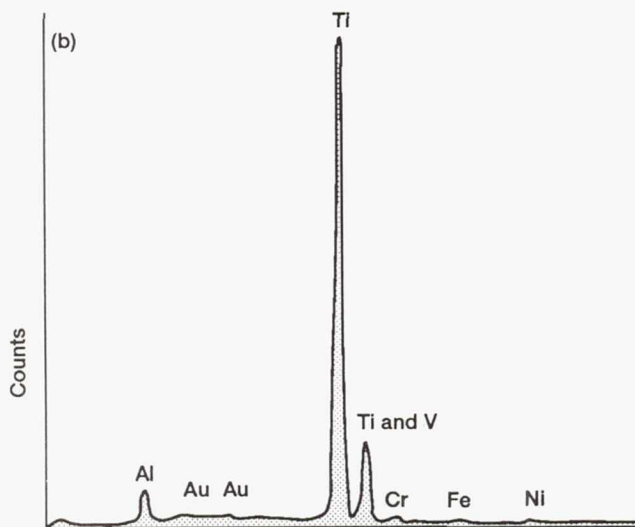
(a) Secondary electron image SEM of clogged wear debris.
 (b) Spot EDX analysis of the clogged wear debris. The thin gold film used to reduce charging of the mount is responsible for the gold signal in the spectrum.

Figure 7.—Clogged wear debris on the wear scar of the pin.

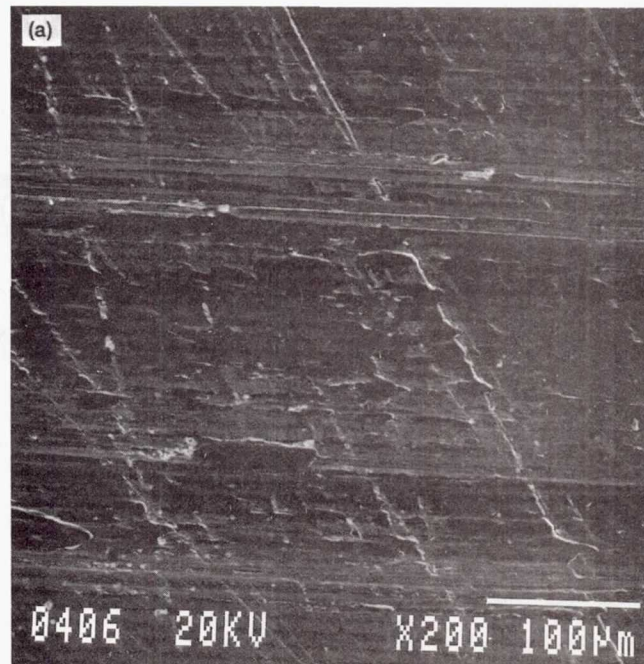
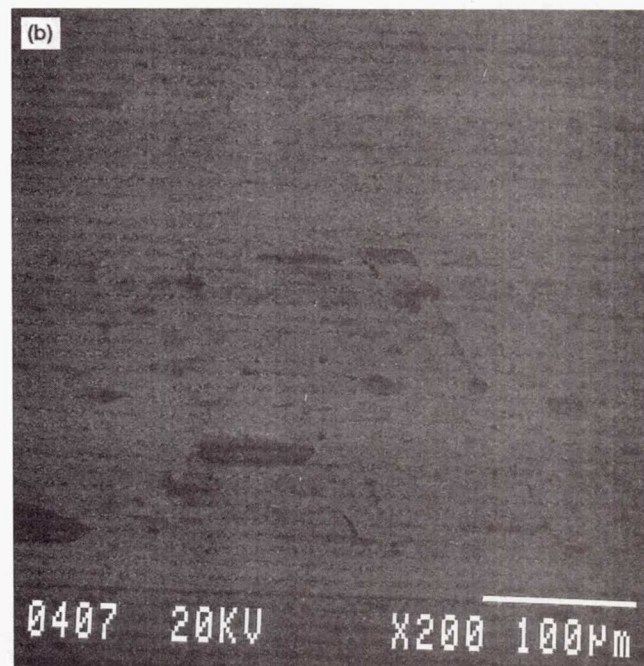
(a) Secondary electron image SEM.
 (b) Backscatter electron image SEM.

Figure 8.—Wear track on Inconel 718 disk showing transfer patches of Ti-6Al-4V.

Figures 8 and 9 show the Ti-6Al-4V patches on the wear track of Inconel 718 disk. The transferred patches occupied a quite large area fraction of the overall wear track. Thus, the severe damage, often referred to as galling, occurred in the unlubricated Ti-6Al-4V to Inconel 718 contact in vacuum (refs. 3 to 5).

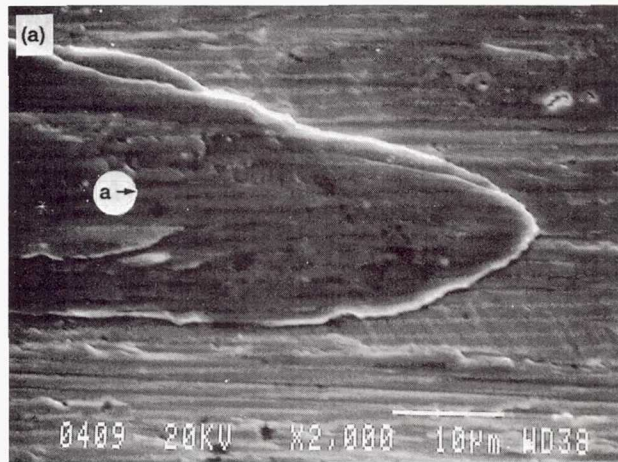
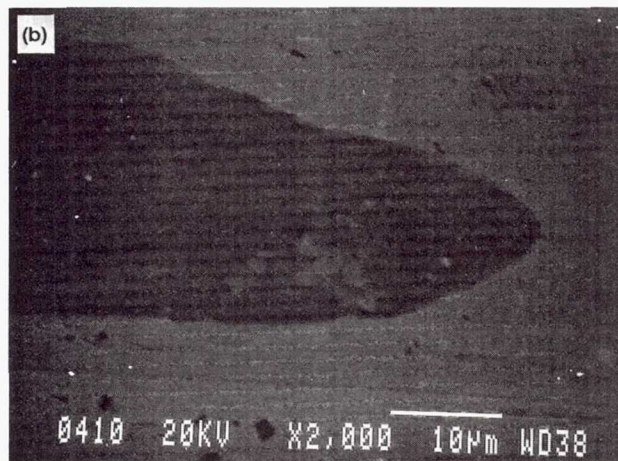
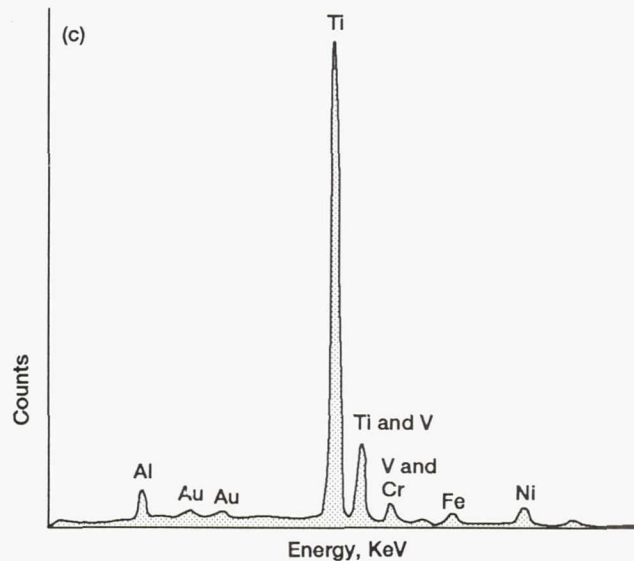
(a) Secondary electron image SEM.

(b) Backscatter electron image SEM.

(c) Energy dispersion X-ray analysis spectrum of transferred film on Inconel 718 disk. Data taken at point indicated in part (a). The thin gold film used to reduce charging of the mount is responsible for the gold signal in the spectrum.

Figure 9.—Large transfer patch of Ti-6Al-4V on Inconel 718 disk.

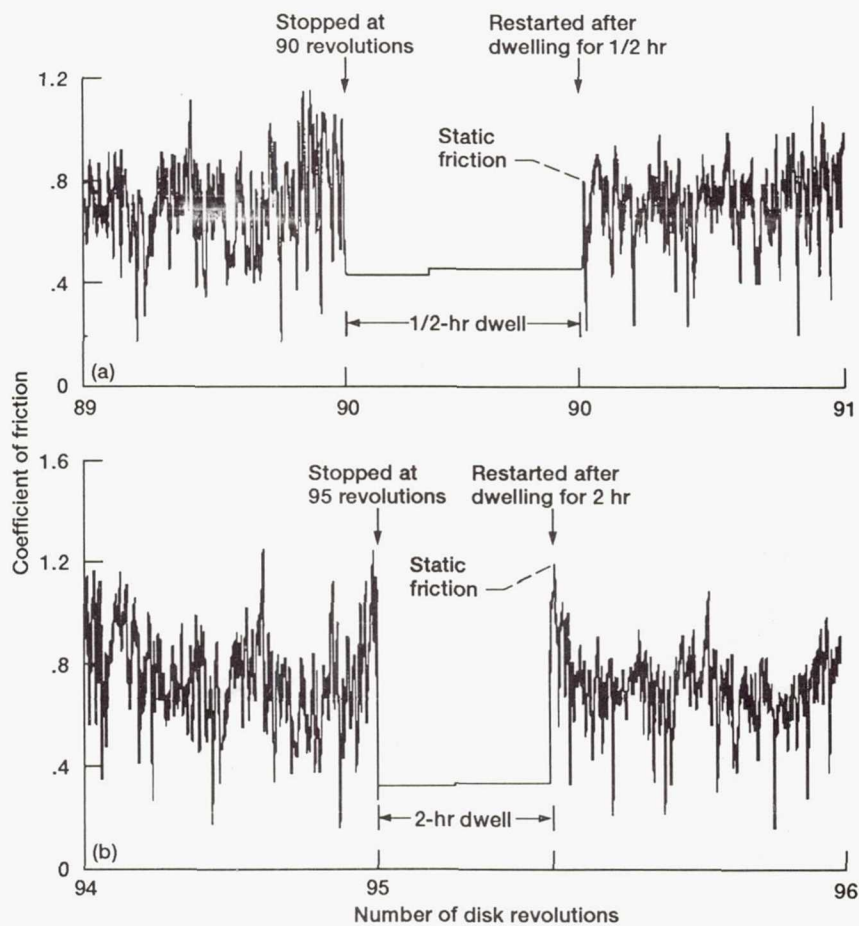
(a) Friction traces before and after dwelling for 1/2 hr.
 (b) Friction traces before and after dwelling for 2 hr.
 Figure 10.—Effect of dwelling on friction at 2.5 N in vacuum.

Figure 10 presents friction traces (coefficient of friction as a function of number of disk revolutions) for a Ti-6Al-4V pin in contact with Inconel 718 disk. At 90 disk revolutions (fig. 10(a)) and at 95 disk revolutions (fig. 10(b)), the sliding motion was stopped, and conditions were held for 1/2 hr and for 2 hr, respectively. After the dwell time, sliding was restarted. The traces clearly show that dwell time had almost no effect on the static coefficient of friction, which was similar before and after the dwell time.

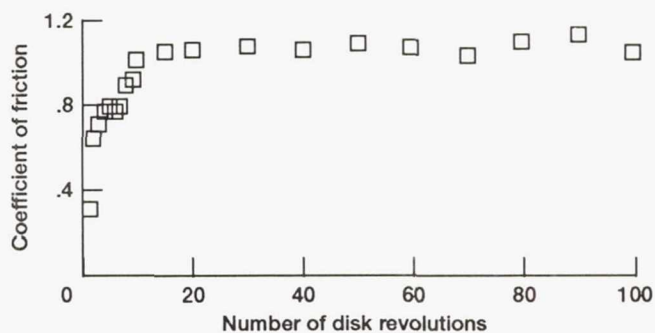
Figure 11.—Coefficients of friction (highest value) for unlubricated Ti-6Al-4V pin sliding against Inconel 718 disk as function of number of disk revolutions at 4 N in vacuum.

Effect of load.—Figure 11 presents the coefficients of friction measured at the load of 4 N. The coefficients of friction were calculated from highest value in friction traces. As might be expected, the friction behavior and the appearance of the galling was essentially the same as observed at 2.5 N.

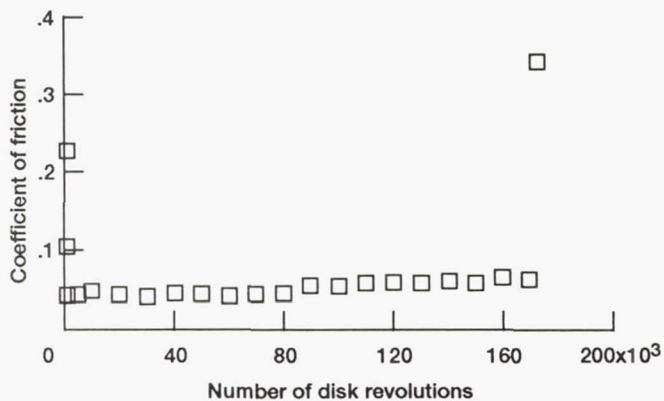
Figure 12.—Coefficients of friction for dry-film-lubricated Ti-6Al-4V pin sliding against Inconel 718 disk at 8.5 N in vacuum.

In vacuum, the coefficient of friction starts relatively high (0.23) but rapidly decreases and reaches an equilibrium value of about 0.04 (fig. 12). It remains constant for a long period of time. The friction trace fluctuated slightly with no evidence of stick-slip behavior (fig. 13). The sliding action finally caused the coefficient of friction to rapidly increase at 172 370 revolutions. Wear damage, which will be discussed later, caused the high friction at this stage.

Worn in vacuum.—At 172 370 revolutions of sliding contact in vacuum (fig. 12), the sliding motion was stopped because of high friction (0.36 or greater) caused by the wear damage. After holding conditions for about 18 hr, the sliding was restarted. The result is presented in figure 16(a). The coefficient of friction after rerun became much lower. Further, the coefficient of friction generally decreased to about 0.05 with increasing number of disk revolutions. This result suggests that the wear damage in vacuum, which caused high friction at 172 370, can self-heal when rerun in vacuum.

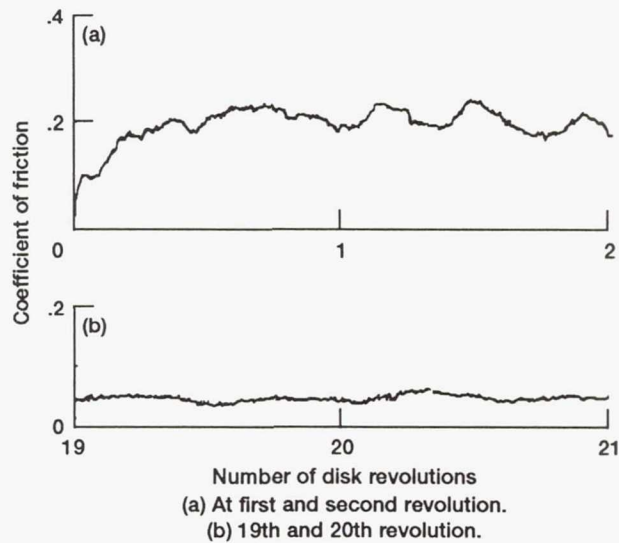
Figure 13.—Friction traces for dry-film-lubricated Ti-6Al-4V sliding against Inconel 718 at 8.5 N in vacuum.

Friction.—Sliding friction experiments were conducted with dry-film-lubricated (Tiolube 460) Ti-6Al-4V pins on Inconel 718 disks at a load of 8.5 N both in vacuum and in air. The results are presented in figures 12 to 14.

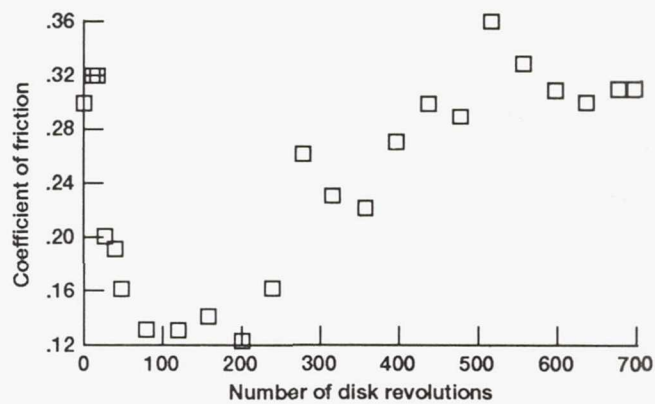
Figure 14.—Coefficients of friction for dry-film-lubricated Ti-6Al-4V pin sliding against Inconel 718 disk at 8.5 N in air.

In air, the coefficient of friction started high (approximately 0.30) in the first 23 revolutions, but decreased and reached an equilibrium value of about 0.1 (fig. 14). Continued sliding caused the coefficient of friction to increase at 270 revolutions. When the coefficient of friction reached an equilibrium value of about 0.3, the experiment stopped (at 700 disk revolutions). The friction trace with disk revolutions to 270 exhibited mild stick-slip behavior (as shown by the representative section in figs. 15(a) and (b)). After 270 disk revolutions, the friction trace exhibited greater stick-slip behavior (fig. 15(c)).

Worn in air and then rerun in vacuum.—After 700 disk revolutions in air (fig. 14), the worn surfaces were at rest, and loose wear particles on the Inconel 718 disk surface were blown off. Then the vacuum chamber was evacuated to 10^{-7} Pa (10^{-9} torr). After dwelling for about 18 hr in contact, the sliding motion was restarted. The coefficients of friction for the pin and disk worn in humid air were much higher than those for the pin and disk worn in vacuum (as shown in fig. 16(a)). Further, the coefficient of friction generally increased with increasing number of disk revolutions.

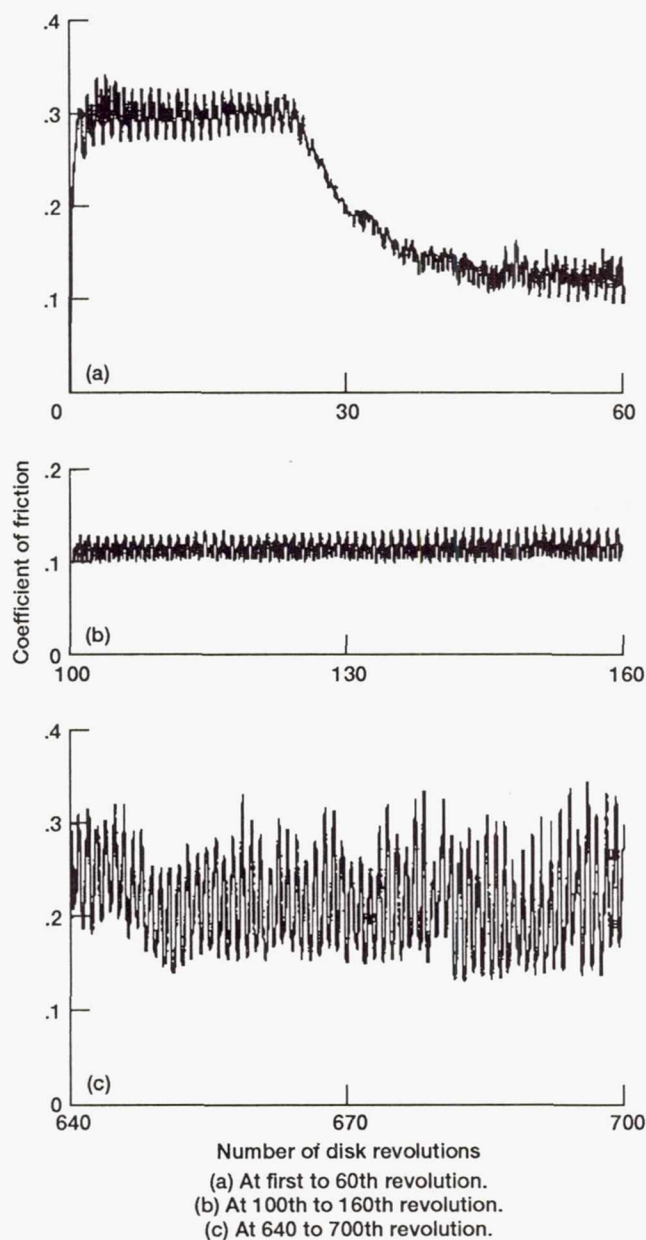
Figure 15.—Friction traces for Ti-6Al-4V pin sliding against Inconel 718 at 8.5 N in air.

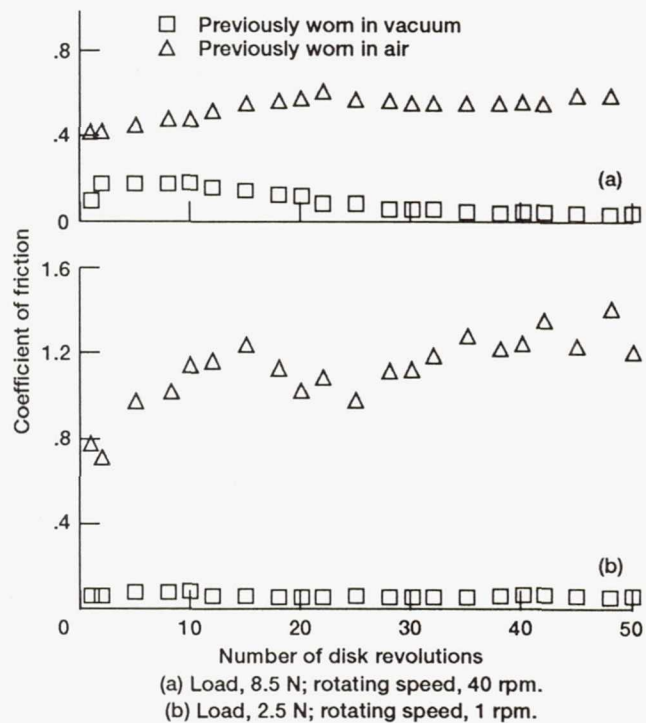
Figure 16.—Coefficients of friction for worn surfaces of dry-film-lubricated Ti-6Al-4V pin sliding against Inconel 718 disk when rerun in vacuum.

After 50 revolutions of sliding contact, the sliding motion was stopped, and the load was changed from 8.5 N to 2.5 N. Contact was maintained for 30 sec, and then sliding was begun at the new load. The changing load from 8.5 N to 2.5 N did not affect the coefficient of friction, as shown in figure 16(b).

After 50 revolutions of sliding contact in vacuum, the sliding motion was stopped, and the load was changed from 8.5 N to 2.5 N. Contact was maintained for 30 sec, and then sliding was begun at the new load. The coefficient of friction continued to increase with increasing number of disk revolutions (fig. 16(b)).

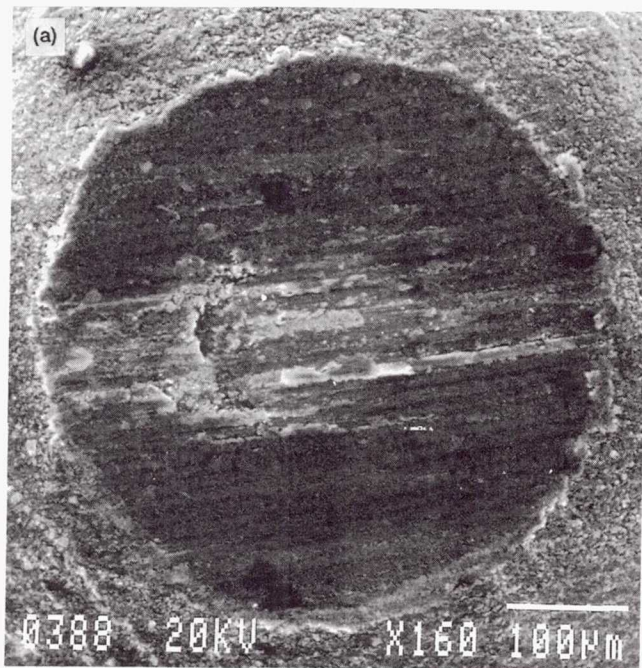
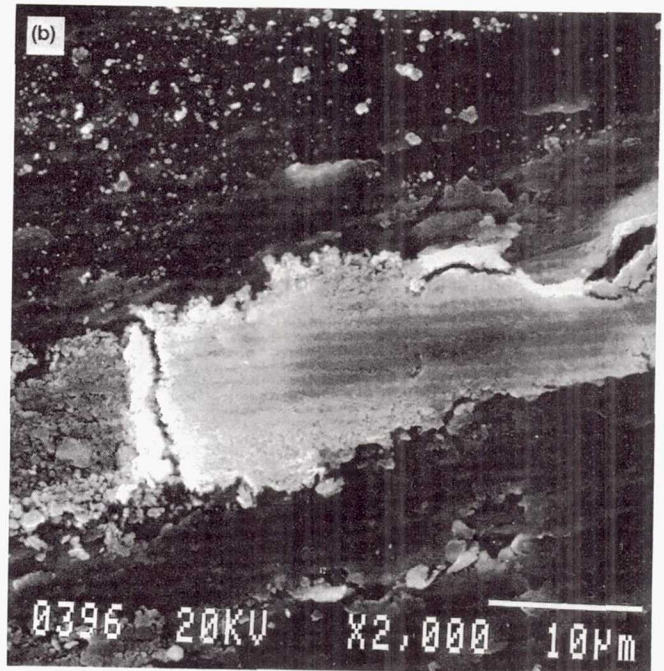
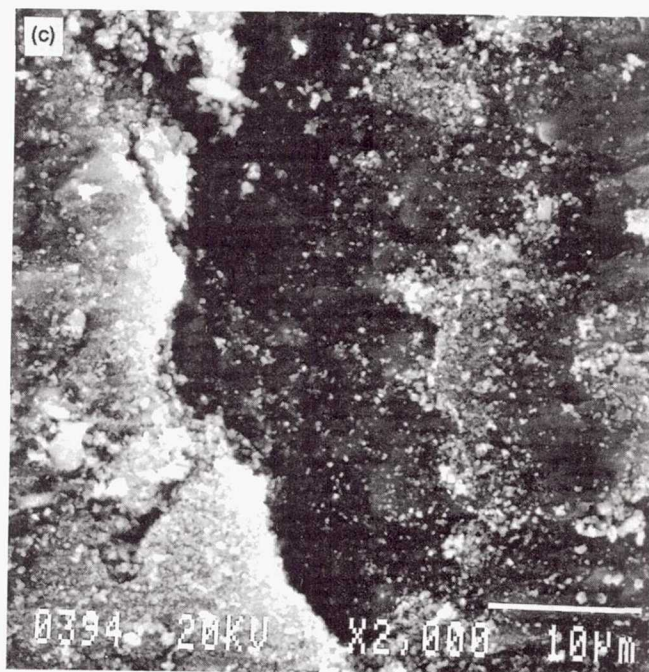
- (a) Low magnification overview showing relatively smooth surfaces at upper and lower areas of wear scar with spalling and tearing center.
- (b) Surface smearing and tearing at the center of wear scar resulting in separation of particles from surface in form of flakes.
- (c) Spalling at the center of wear scar.

Figure 17.—Wear scar produced in dry-film-lubricated Ti-6Al-4V pin after sliding against Inconel 718 disk in vacuum.

Worn in vacuum.—SEM photographs of the worn surfaces of the dry-film-lubricated Ti-6Al-4V pin sliding against Inconel 718 disk in vacuum show surface smearing, tearing, and spalling of the dry-film lubricant (figs. 17 to 20). This type of wear damage, which results from fatigue of the dry-film lubricant, is often referred to as spalling (refs. 3 to 5).

Figure 17(a) shows the relatively smooth burnished surfaces in the upper and lower regions of the wear scar and the rougher surface at the center of the scar. Closer SEM examination and EDX analysis of the wear damage at the center of the wear scar showed that the flake-like wear debris (fig. 16(b)) resulted from surface smearing and tearing of the dry-film lubricant. EDX analysis of the flake-like debris indicated that it mainly contained the elements of the MoS_2 lubricants. Figure 17(c) shows a crater (dark area) where fragments of the dry-film lubricant were removed and the Ti-6Al-4V substrate was exposed. The EDX analysis of the crater indicated that it mainly contained elements of the Ti-6Al-4V.

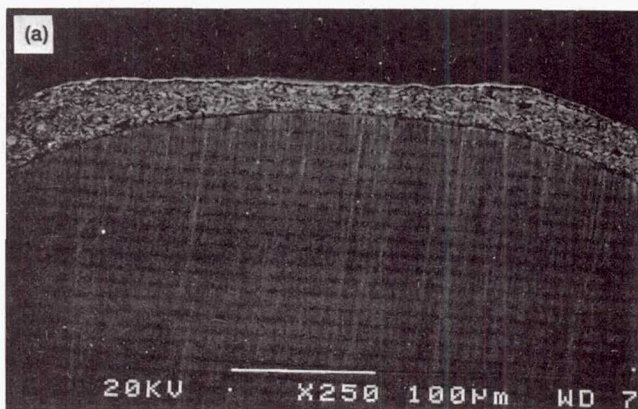
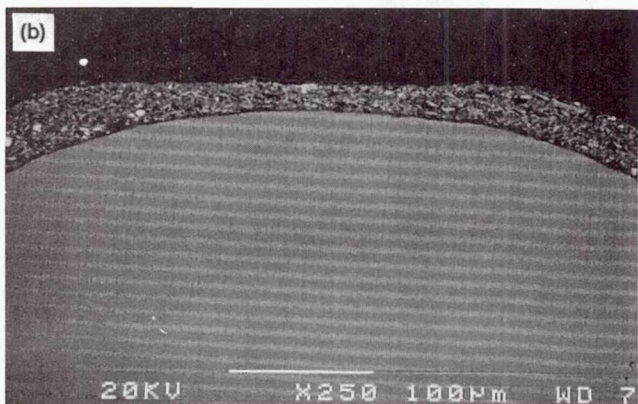
(a) Secondary electron image SEM.
(b) Backscatter electron image SEM.

Figure 18.—A taper cross section of the worn surface of dry-film-lubricated Ti-6Al-4V pin at angle of 45° to the worn surface.

Figures 18 and 19 show a taper cross section of the worn surface of the dry-film-lubricated Ti-6Al-4V pin at an angle of 45° to the worn surface. The cross-section SEM photographs clearly indicate that most of the dry-film lubricant remains even after about 170 000 revolutions in vacuum. The film thickness of the remaining lubricant is about 15 μm . Close SEM examination reveals dense, amorphous-like material in the area right underneath the worn surface (fig. 19 (a)).

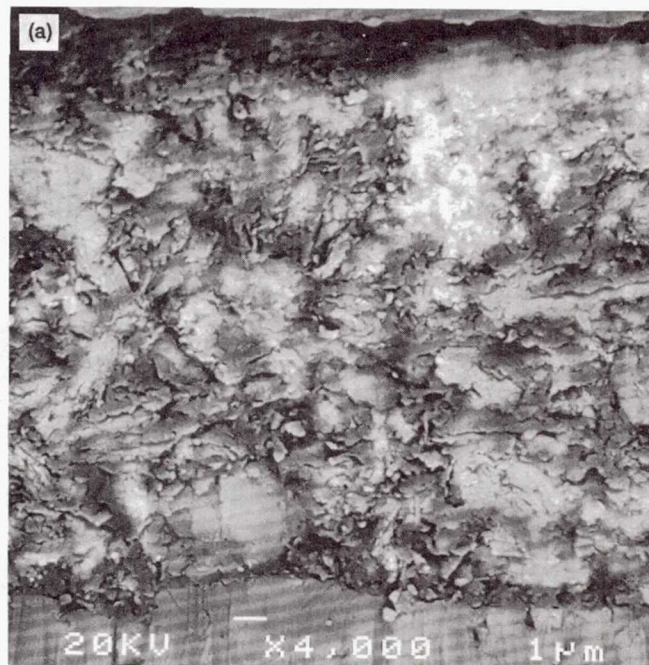
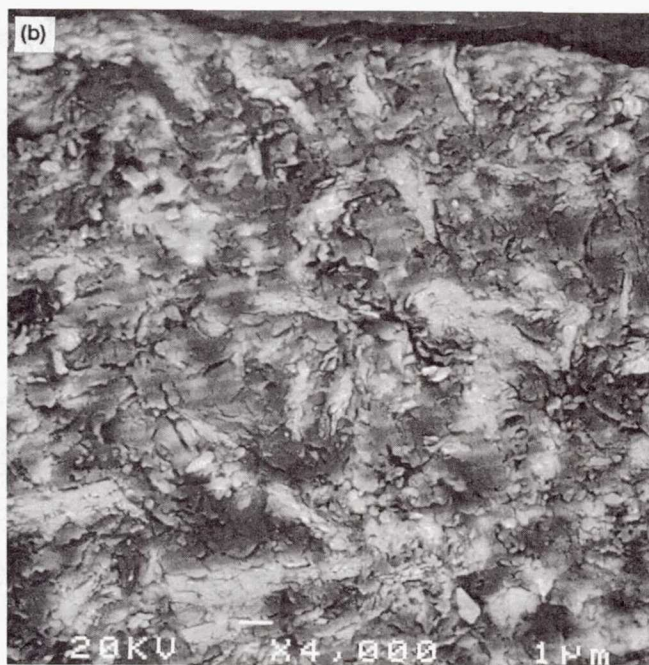
(a) Cross section of worn surface.
(b) Cross section of the as-coated area of dry-film-lubricant.

Figure 19.—Comparison of microstructures. Backscatter electron image SEM.

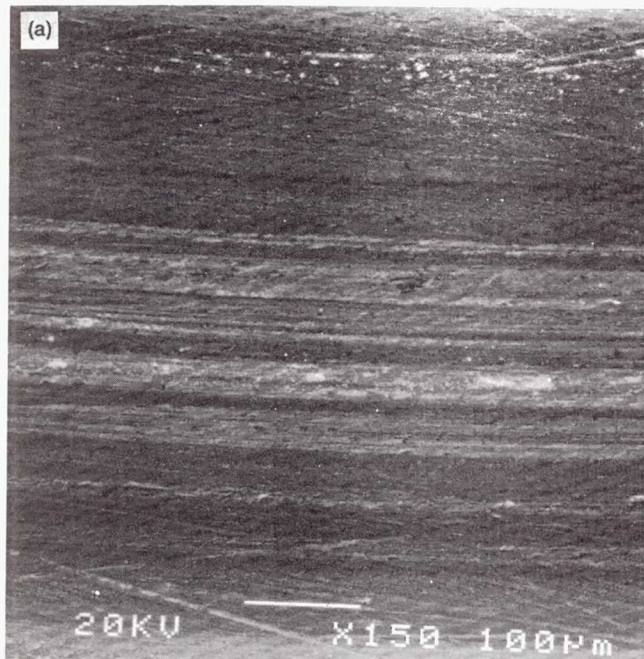
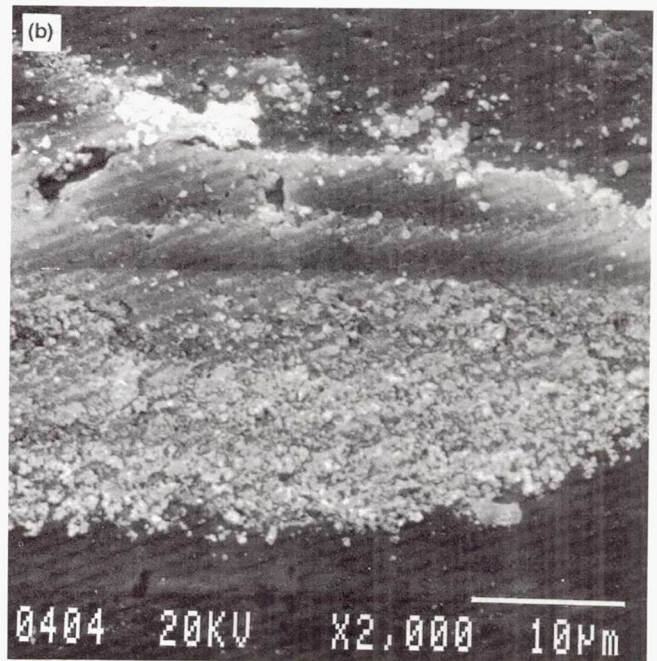
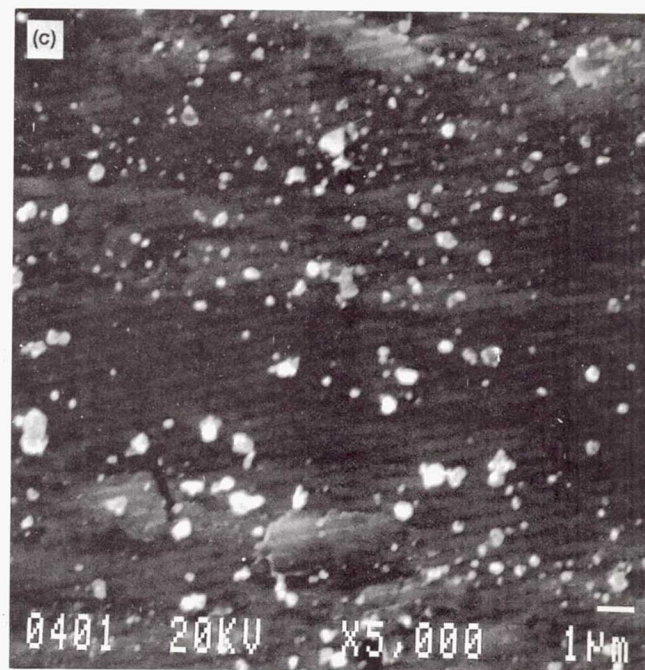
(a) Low magnification overview of wear track.

(b) Detailed view showing transfer patches at center of wear track.

(c) Detailed view showing powder-like wear debris of dry-film lubricant.

Figure 20.—Wear scar produced on Inconel 718 disk after sliding against dry-film-lubricated Ti-6Al-4V pin in vacuum.

Figure 20(a) shows the relatively smooth track of the Inconel 718 disk with transferred patches of the dry-film lubricant observed (even in the low magnification view) mainly at the center of the wear track. Closer SEM examination of the center and upper regions of the track shows the transferred wear particles to be in the form of flakes and powders (fig. 20(b) and (c)).

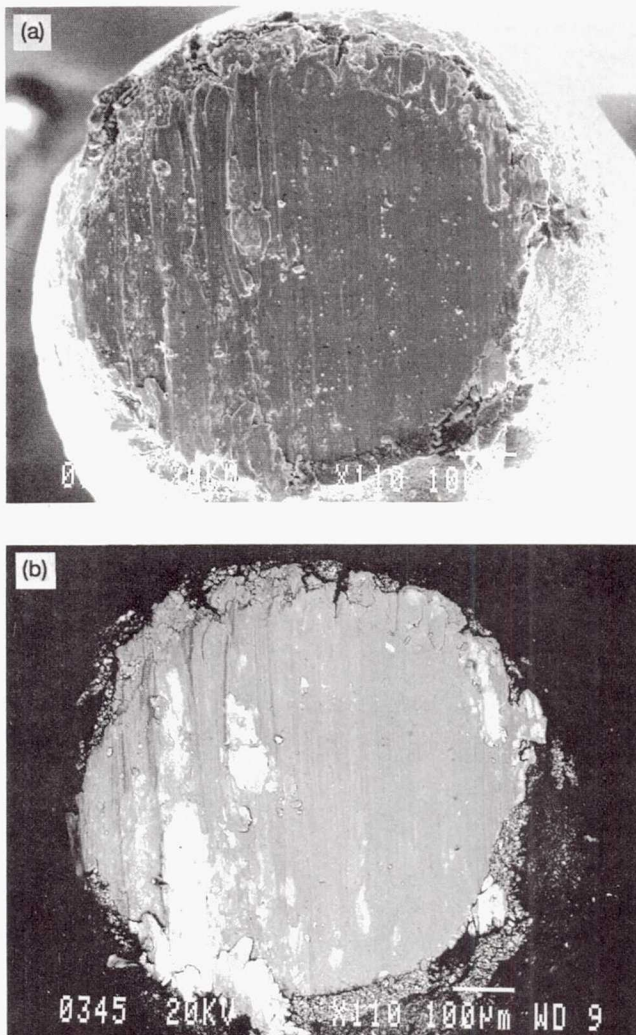
(a) Secondary electron image SEM.
(b) Backscatter electron image SEM.

Figure 21.—Wear track produced in dry-film-lubricated Ti-6Al-4V pin after sliding against Inconel 718 disk in air and then rerun in vacuum.

Worn in air and rerun in vacuum.—Scanning electron micrographs of the worn surfaces of the dry-film-lubricated Ti-6Al-4V pin and Inconel 718 disk run in air for 700 disk revolutions and then rerun in vacuum for 100 disk revolutions are shown in figures 21 to 27. Figure 21 shows that both plastic deformation and ductile fracture occurred in the dry-film-lubricated Ti-6Al-4V pin. The backscatter photograph (fig. 21(b)) reveals three different materials: (1) the light areas in the photomicrograph show where the transfer patches from the Inconel 718 disk stayed on the Ti-6Al-4V pin, (2) the grayer areas show the Ti-6Al-4V substrate with no dry-film lubricant present, and (3) the salt and pepper-like areas around the edge of wear scar show the dry-film lubricant. In addition to the major elements of Inconel 718, the transfer patches also contained elements such as molybdenum and sulfur from the lubricant (fig. 22(a)). On the other hand, the gray areas contained only the elements of Ti-6Al-4V (fig. 22(b)).

Thus, the worn surface of the pin and disk first run in humid air and then rerun in vacuum was completely different from that of the pin and disk run only in vacuum. The surface worn in humid air (figs. 21 and 23) exhibited galling accompanied by the severe surface damage and extensive transfer of the Ti-6Al-4V to the Inconel 718, or vice versa.

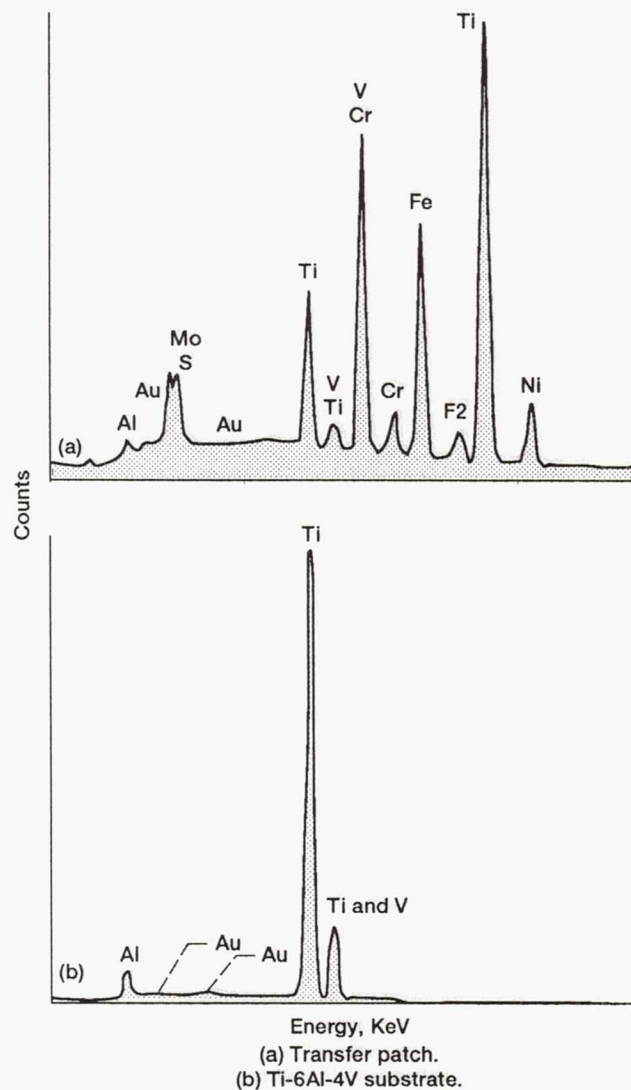
Figure 22.—EDX analysis of wear scar produced in dry-film-lubricated Ti-6Al-4V pin after sliding against Inconel 718 disk in air and then rerun in vacuum. The thin gold film used to reduce charging of the mount is responsible for the gold signal in the two spectra.

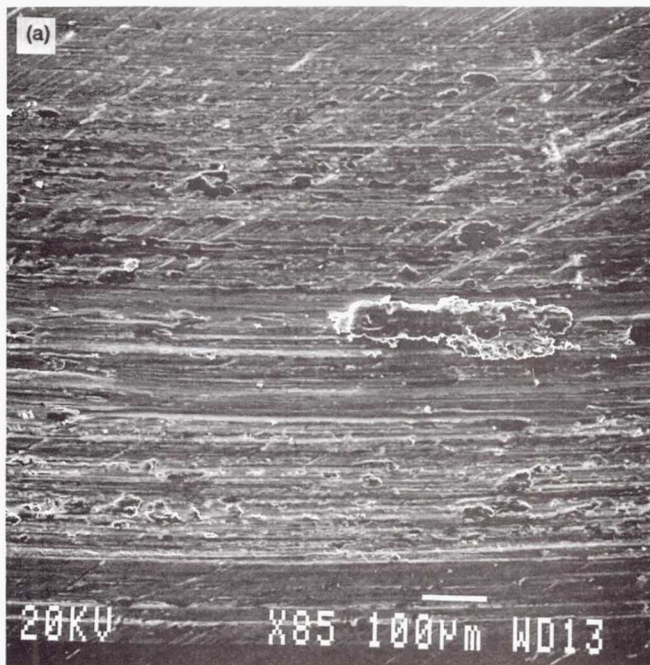
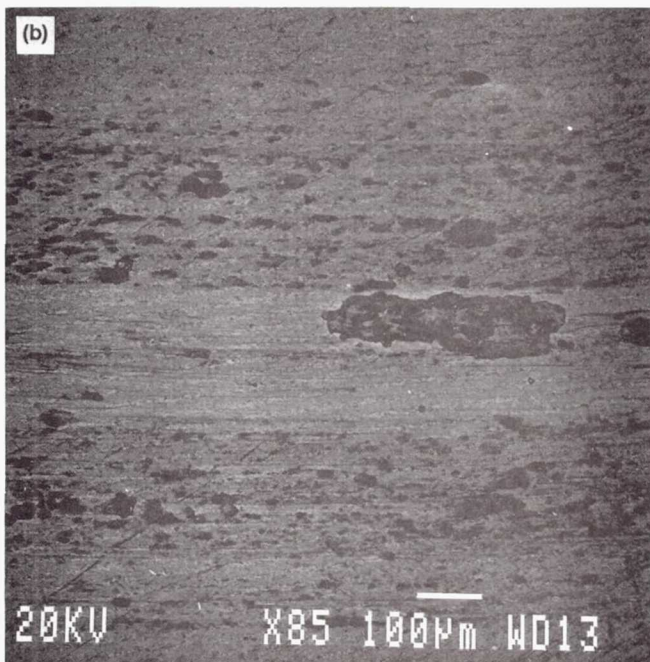
(a) Secondary electron image SEM.
(b) Backscatter electron image SEM.

Figure 23.—Wear track produced in Inconel 718 disk after sliding against dry-film-lubricated Ti-6Al-4V pin in air and then rerun in vacuum.

The large patches seen on the wear track of the Inconel 718 disk of figure 23 are also apparent in the backscatter photomicrograph of figure 23(b), which indicated the dark areas to be the transfer patches from the Ti-6Al-4V. Further, the EDX analysis (fig. 24(a)) of the transfer patch shows that it mainly contained elements of the Ti-6Al-4V with a small amount of elements from the dry-film lubricant. The rest of the areas in the wear track contained relatively smaller amounts of elements from the Ti-6Al-4V and dry-film lubricant (fig. 24(b)). Closer SEM examination (fig. 25) of the wear track reveals extensive plastic shearing of the Inconel 718 disk.

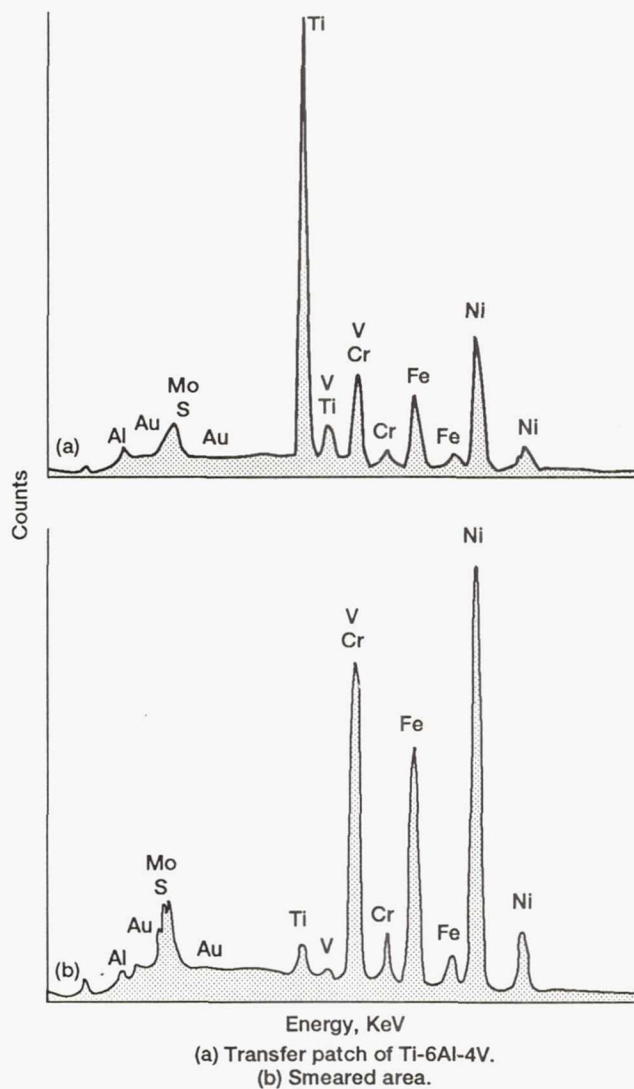
Figure 24.—EDX analysis of wear track produced in Inconel 718 disk after sliding against dry-film-lubricated Ti-6Al-4V pin in air and then rerun in vacuum. The thin gold film used to reduce charging of the mount is responsible for the gold signal in the two spectra.

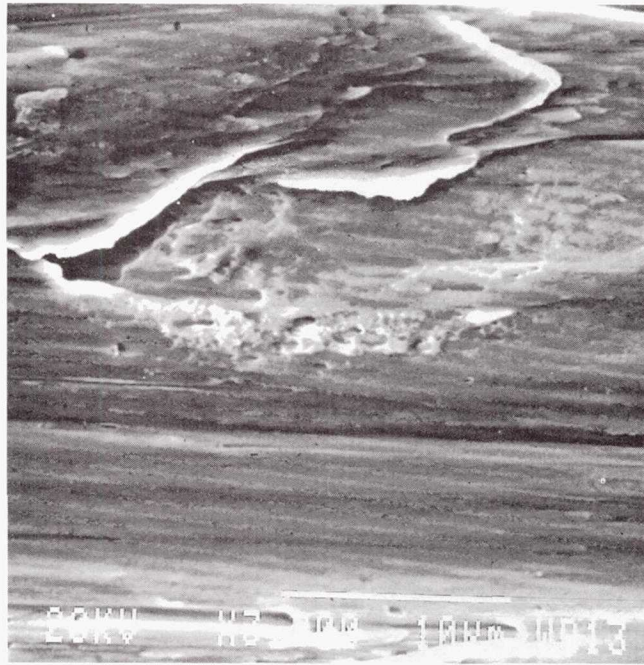
Figure 25.—SEM photomicrograph of wear track showing extensive plastic shearing in Inconel 718 disk after sliding against dry-film-lubricated Ti-6Al-4V pin in air then rerun in vacuum.

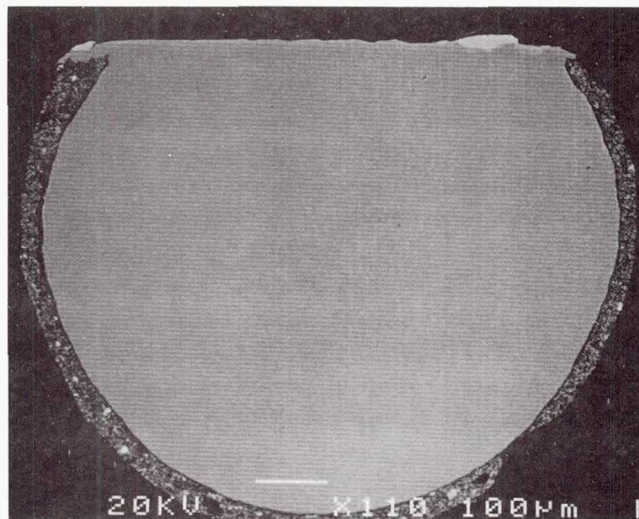
Figure 26.—A taper cross section of the worn surface of the dry-film-lubricated Ti-6Al-4V pin at an angle of 45° to the worn surface. Overview (backscatter electron image SEM) showing extrusion out of the wear scar, transferred patches of Inconel 718, and no presence of the dry-film lubricant on the worn surface.

Figure 26, a taper cross section of the worn surface of the dry-film-lubricated Ti-6Al-4V pin shows clearly that the dry-film lubricant is not present on the worn surface. Further, in the overview photomicrograph, extrusion out of the wear scar and transferred patches of Inconel 718 are also well defined because of effective atomic number contrast. In figure 27 plastic deformation of the Ti-6Al-4V (extrusion out of the wear scar) and local solid-phase welding between Ti-6Al-4V and transfer patch of Inconel 718 (often referred to as scuffing) were well defined by the backscatter electron image SEM.
